585 Springston Rolleston Road
Rolleston
Christchurch

Report Title	Geotechnical Investigation - 585	Springston Rollest	on Road, Rolles	ston
Project No.	16130.000.000	Doc ID	01	
Client	Urban Estates Ltd	Client Contact	Brad Wilso	on
Distribution (PDF)	Brad Wilson			
Date	Revision Details/Status	WP	Author	Reviewer
27/05/2019	Issued to Client	DF	JW	GM

1 Introduction

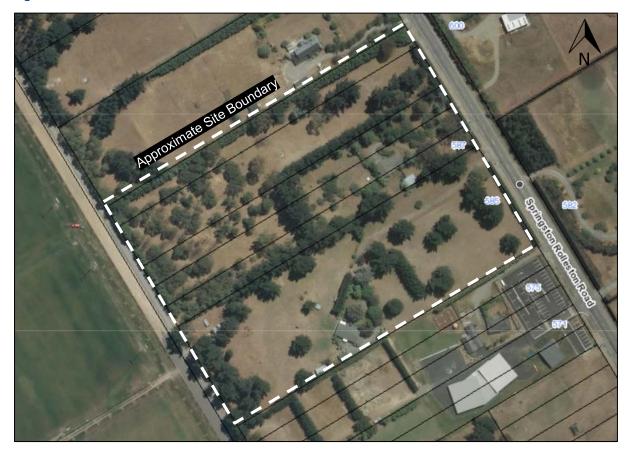
Image sourced from Canterbury Maps

Figure 1: Site Location

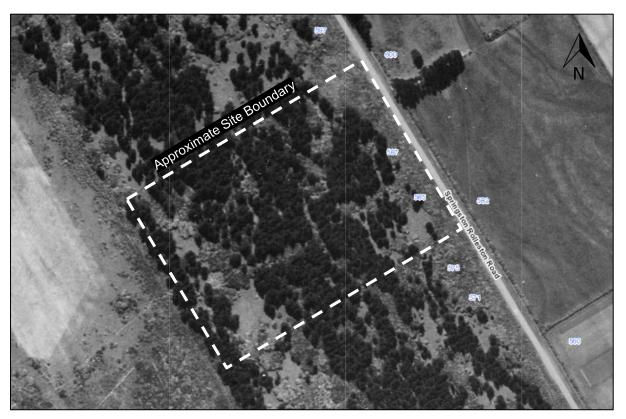
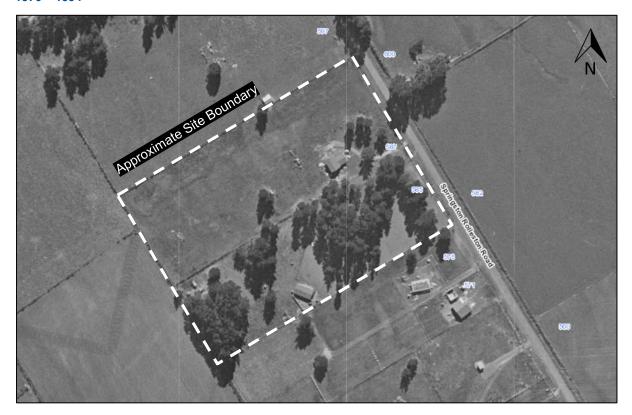
Figure 2: Historical Aerial Photography

1940 - 1944

1970 - 1994

The site comprises relatively flat ground, with gentle undulations and shallow depressions in some areas. As evident on historical aerial imagery (Figure 2) and observed during the site walkover conducted on 7 May 2019, undulating and depressed ground can be attributed to paleo-channels, which traverse the site in a general northwest to southeast trend. Due to the vegetation on site obscuring the evidence of paleo-channels in the aerial photographs, the inferred paleo-channels have not been mapped.

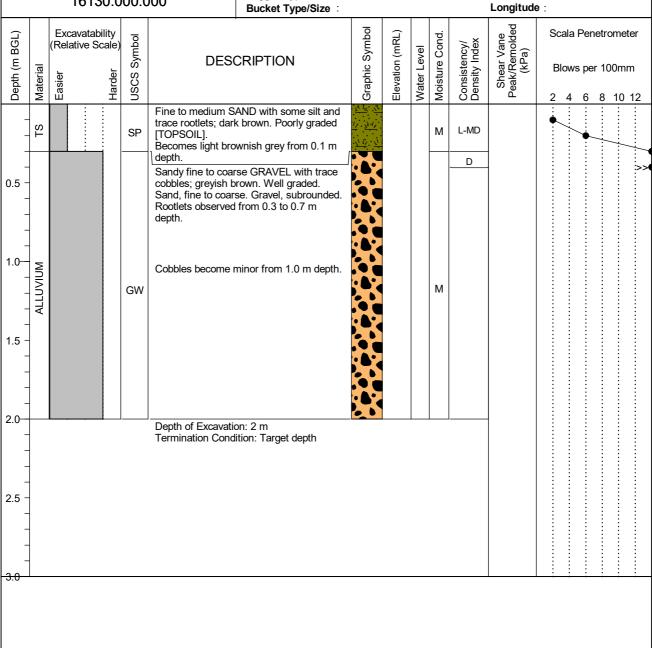
Scala Penetrometer met practical refusal Standing groundwater was not encountered

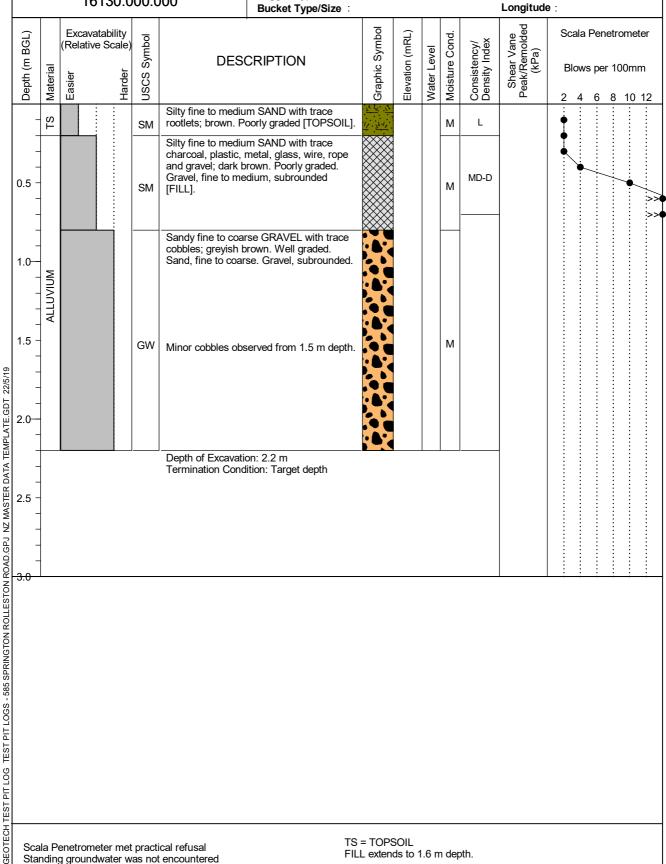
Scala Penetrometer met practical refusal Standing groundwater was not encountered

TS = TOPSOIL FILL extends to 1.6 m depth.

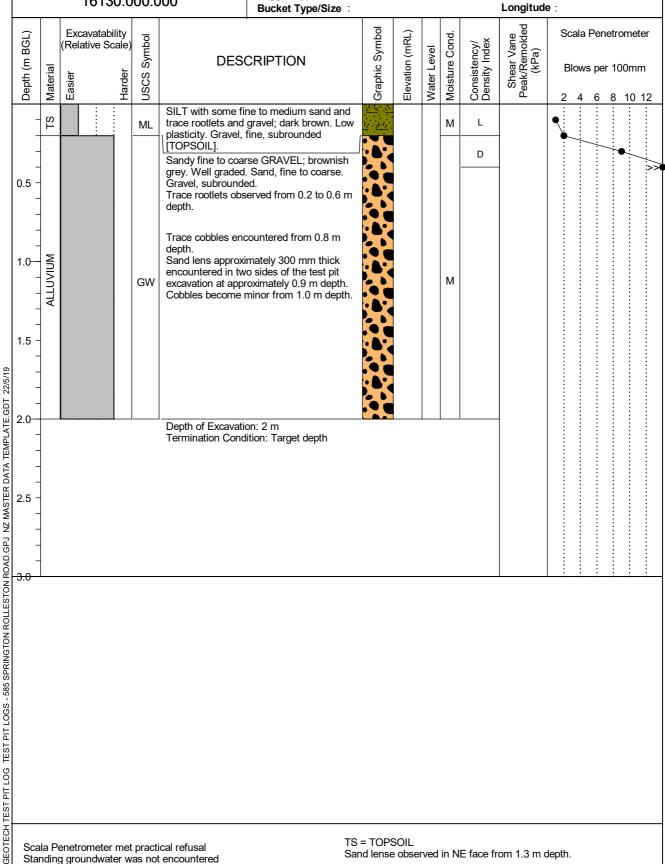
Scala Penetrometer met practical refusal Standing groundwater was not encountered TS = TOPSOIL Sand lense observed in NE face from 1.3 m depth.
